# Manhole Inspection Summary

Manhole # S47E2\_007MH

**Location** Address: **4122 Grace-Curtis**

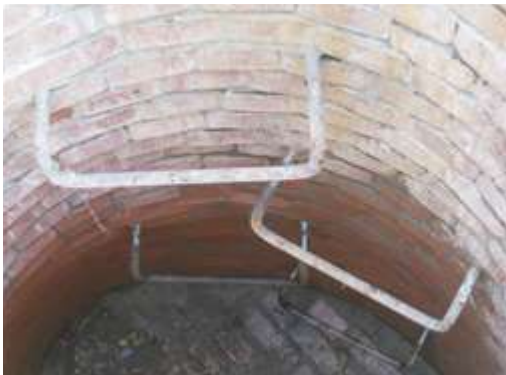
Steps

Count: **4** Missing: **0** ☐ Corroded

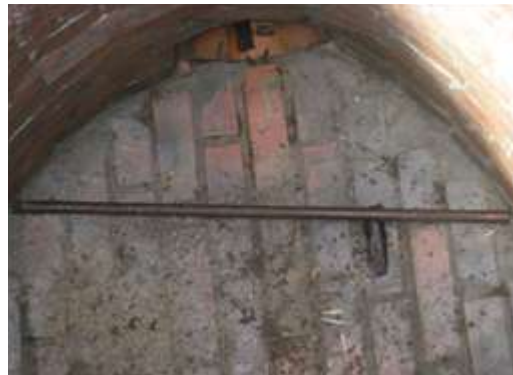
Defect 1

Pole in manhole

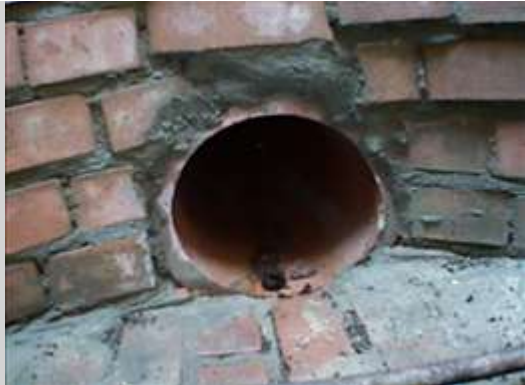
12 O'Clock Outflow

8 in. Circular Gravity Sewer  
Pipe Out @ 12 O'Clock

Pipe Height: **8.4** (in.) Rod and Bar (Angled)

Pipe Material: **Clay** ☐ Pipe Lined

Infiltration: **None** Pipe Seal Cond: **Sound**
